**RACOLA TAILINGS DAM
WASHINGTON COUNTY, MISSOURI
MO 30475**

**PHASE 1 INSPECTION REPORT
NATIONAL DAM SAFETY PROGRAM**

MISSOURI INVENTORY NO. 30475

PREPARED BY
INTERNATIONAL ENGINEERING COMPANY, INC.
CONSULTING ENGINEERS
SAN FRANCISCO, CALIFORNIA

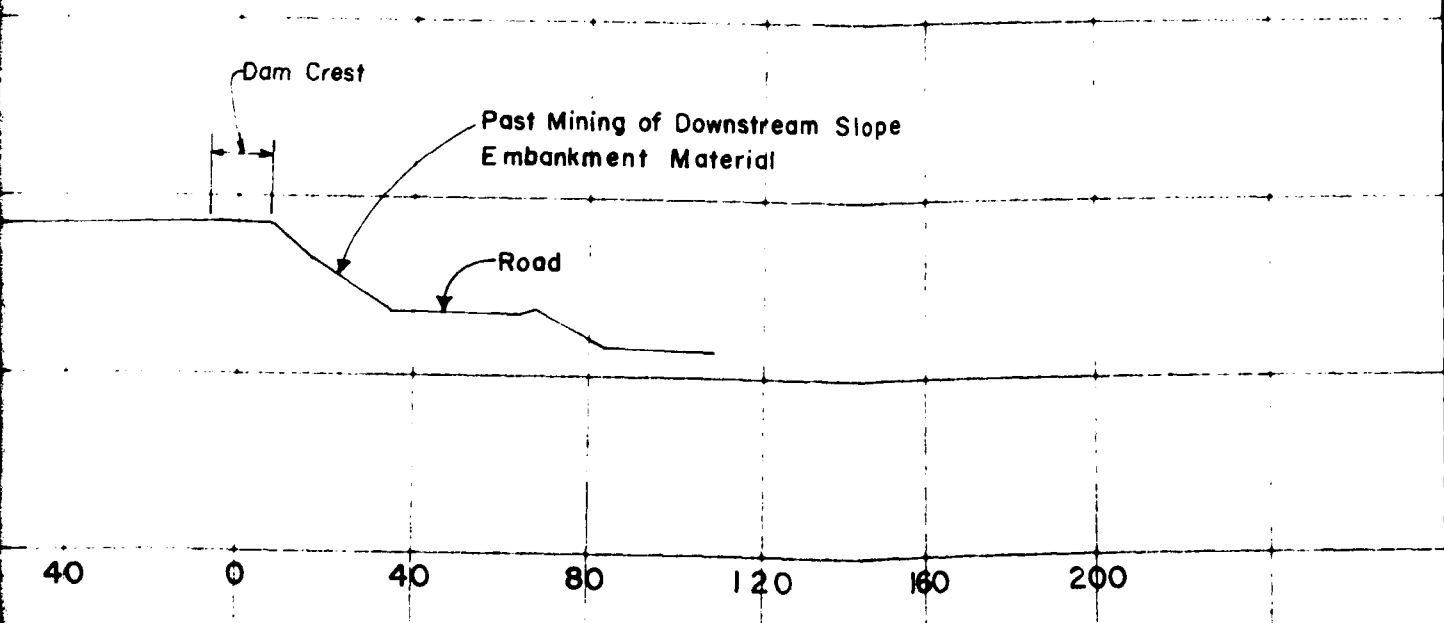
CROSS-SECTION AT STA. 6+00

No functional spillway was observed. The two outlet pipes located appear to be incapable of passing impounded water. The lack of a spillway increases the likelihood of overtopping. The downstream slopes near Stations 30+00 and 6+00 are excessively steep due to past mining of gravel from the embankment toe.
